# Demonstration of Cooling Savings of Light Colored Roof Surfacing in Florida Commercial Buildings: Retail Strip Mall

Danny Parker, Jeffrey Sonne, and John Sherwin

FSEC-CR-964-97

**FINAL REPORT**

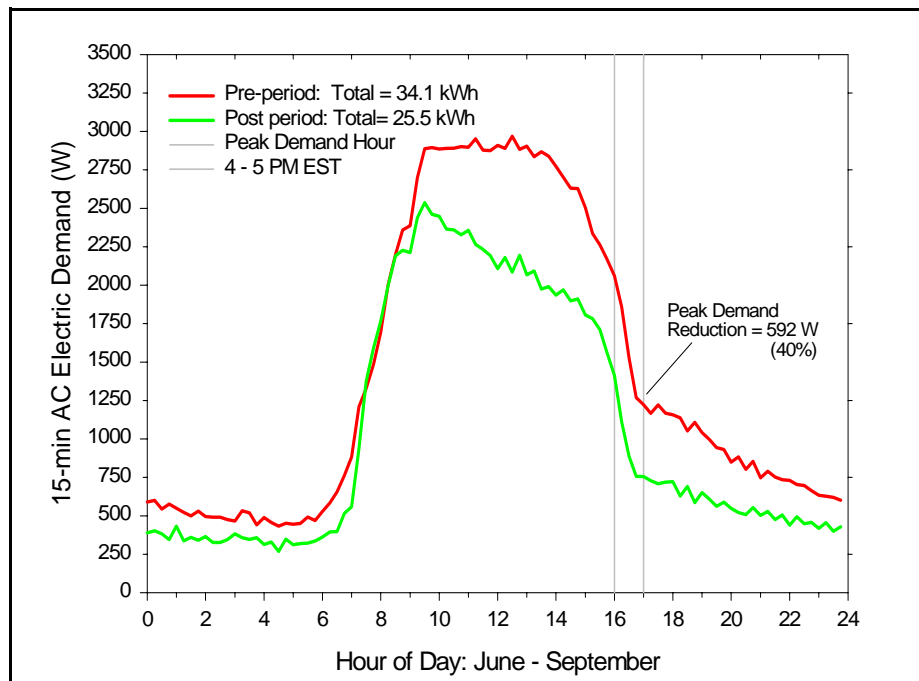
**Figure E-1. Average AC demand profile during pre and post treatment periods for all seven shops.**

The space cooling energy demand reduction was concentrated during the summer afternoon and early evening hours between 11 AM and 7 PM as seen in Figure E-1. During the utility coincident peak demand period (defined as 4 - 5 PM EST or 5 - 6 PM EDT) the overall electric demand reduction averaged 592 W (from 1469 to 877 W) or 40.3%.

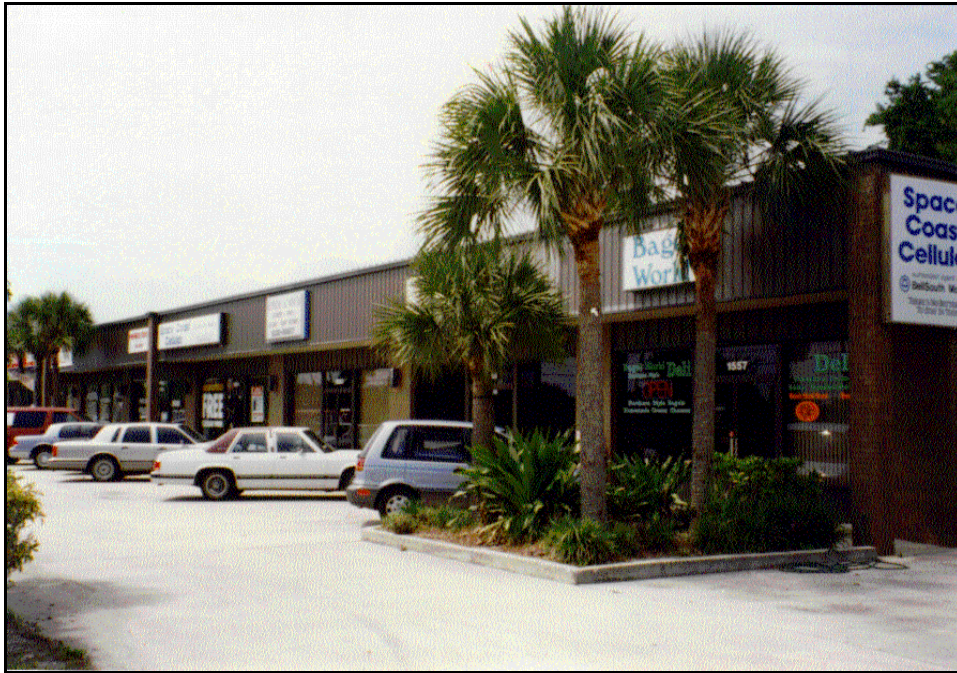
**Figure 1.** Strip mall used as project test site. There is a large section of east facing glass in each store front.

The site is on U.S. Highway 1 (Figure 1); the metal building is 12,500 square feet with a total of eight shops. Each store front is approximately 25 x 50' with large glazed store fronts facing east. The shops are as follows from the north to the south:

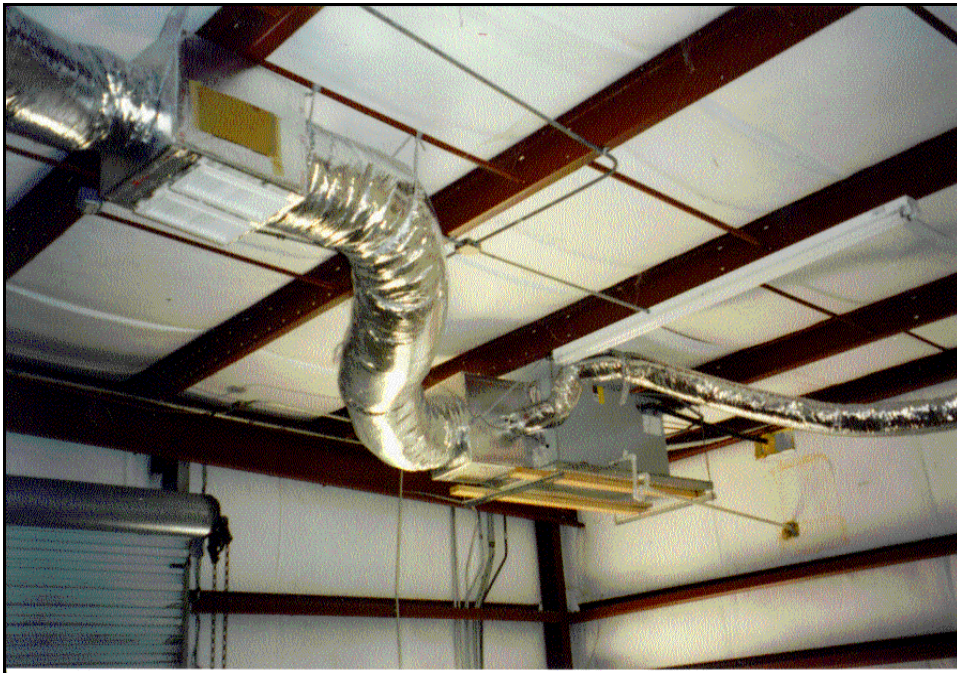
**Figure 2.** View of roof plenum showing R-11 batts on purlins separated by metal studs with air handler and thermal distribution system located inside the plenum. Acoustic ceiling tiles are typically suspended on the metal frame just below the air handler.

The roof is an un-surfaced galvalum metal roofing over metal studs with R-11 insulation suspended underneath on purlins (Figure 2). Dropped acoustic ceiling panels are located in each bay with the plenum containing the air handler and thermal distribution system. R-11 fiberglass batts are located on above the acoustic insulation panels. A contractor examined the roof and indicated that the site’s metal roof could be readily resurfaced to white using available products.

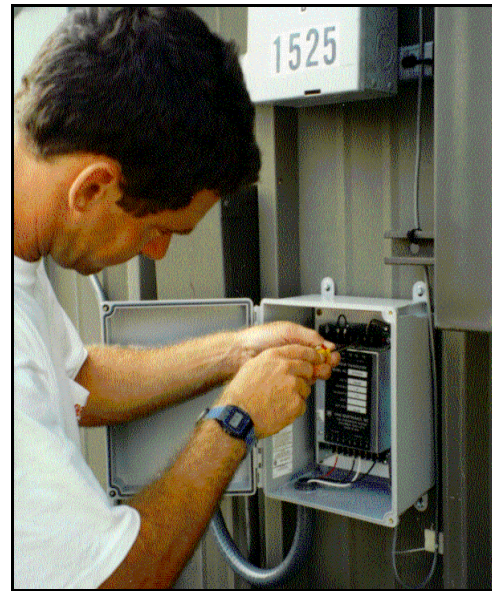
Figure 3. AC power transducer.

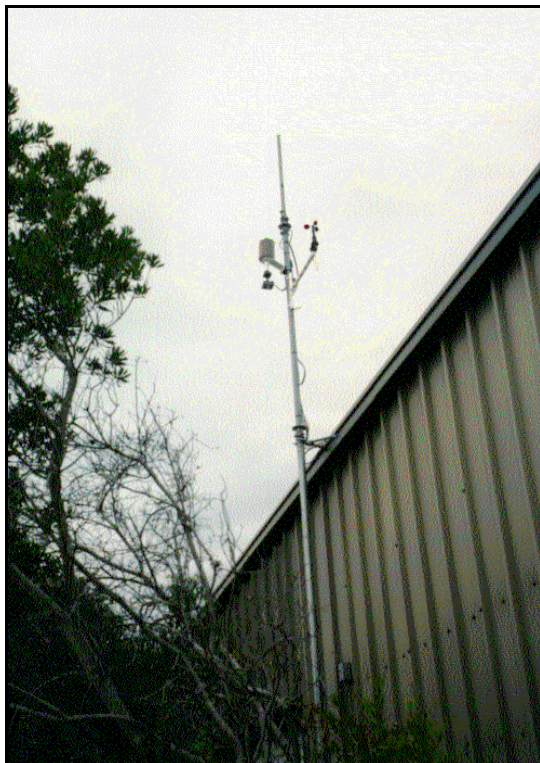
Figure 4. Meteorological tower on the south side of the building.

Meteorological conditions monitored at the site included ambient temperature, relative humidity, insolation and wind speed (Figure 4). Temperature readings were obtained at three points on the roof consisting of the metal roof surface, underside surface of the insulation, the plenum air temperature, and the conditioned interior air temperatures.

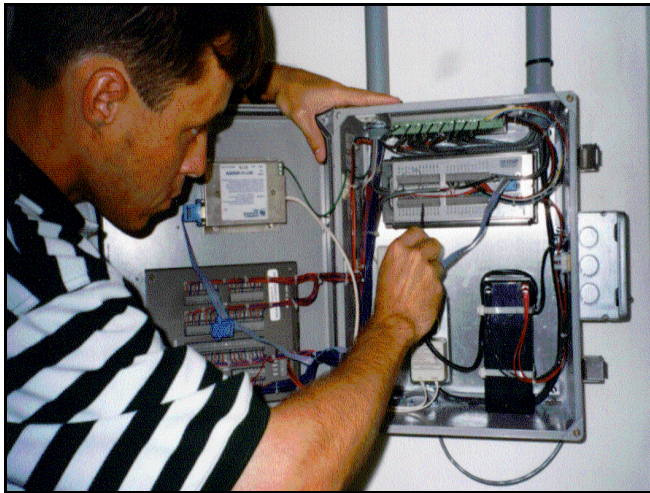
**Figure 5. Final check out of site datalogger.**

A *Campbell Scientific model CR10* datalogger was used to convert the analog and pulse instrument outputs to digital format (Figure 5). Instrument data were read at 5 second intervals and integrated or totaled values were recorded by the datalogger every 15 minutes. Data were transferred from the datalogger via a telephone modem to the mainframe computer each evening. The data are then automatically plotted to summarize the daily performance parameters measured. Plots were examined by the project engineer the following morning to insure reliable data collection.

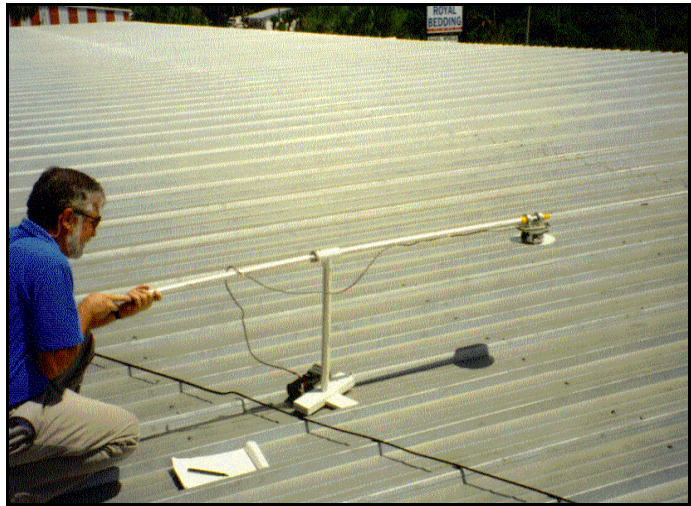
Figure 6

the amount of radiation being reflected from the roof surface (Figure 6). The output of the PSP was recorded on a *Fluke 77 Multimeter* over a period of approximately 30 seconds. The ratio of the reflected flux measurement to that of the incident solar reading was taken as the reflectivity of the surface.

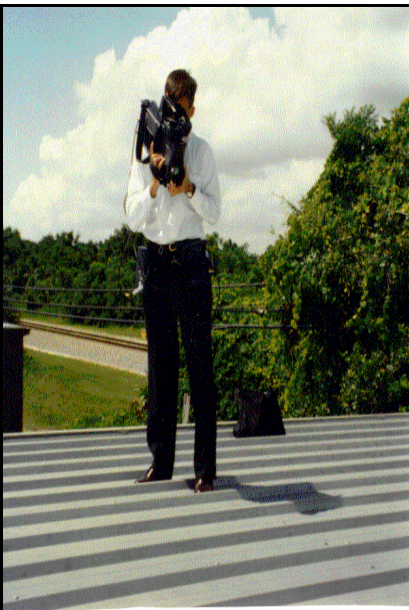
Figure 7

Examination of the exposed exterior roof surface with an infrared camera at mid day on June 9<sup>th</sup>, 1996 (Figure 7) revealed temperatures of over 150° F (Figure 8). Examination of the thermal conditions on the building interior (Figure 9 and 10) showed elevations of 5° F above room conditions on the insulation surface and as much as 15° F on the metal studs.

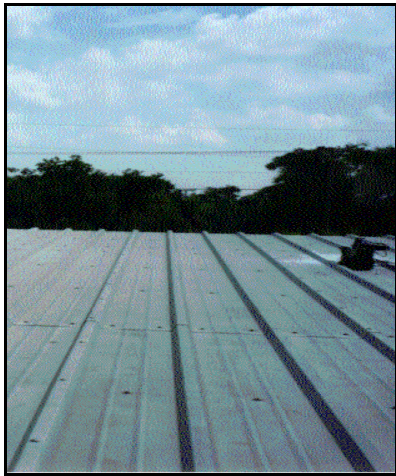
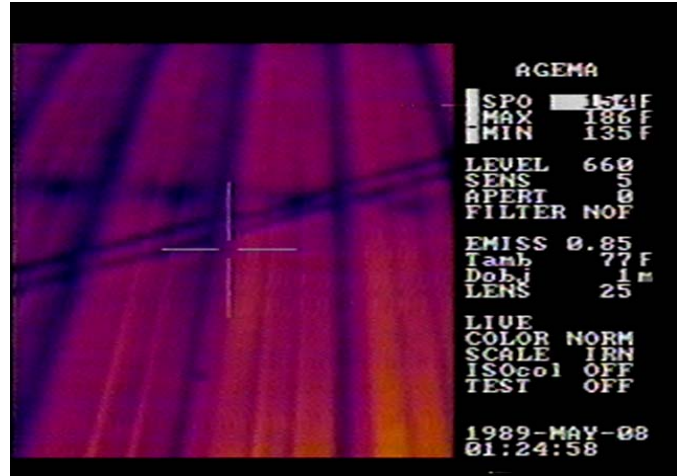
Figure 8. Visible and infrared image of un-coated metal roof. Roof surface is 154°- 160°F.

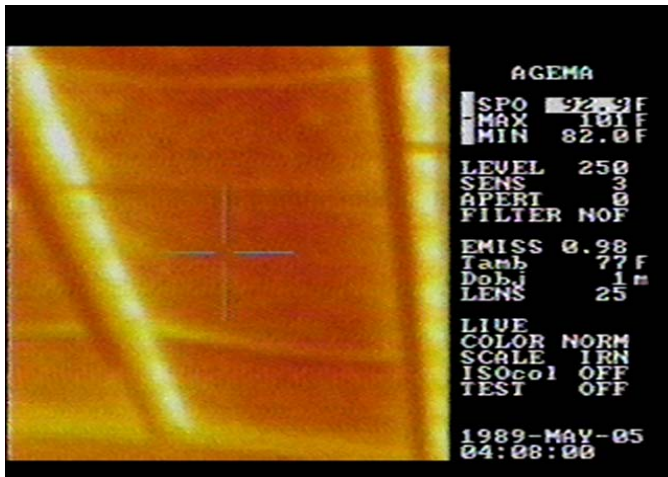
Figure 9. Infrared image of ceiling showing suspended batt insulation between metal trusses. Interior insulation surface temperature is 93°F. Metal studs are hotter than 101°F. See Figure 2 for visible image.

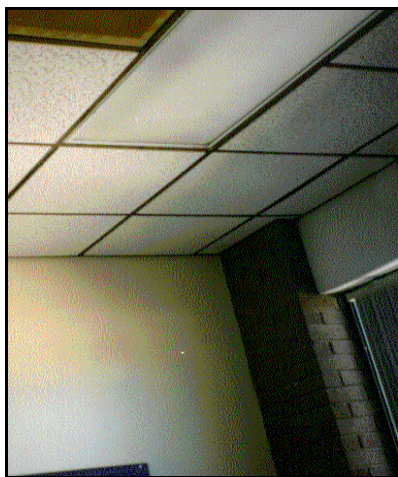
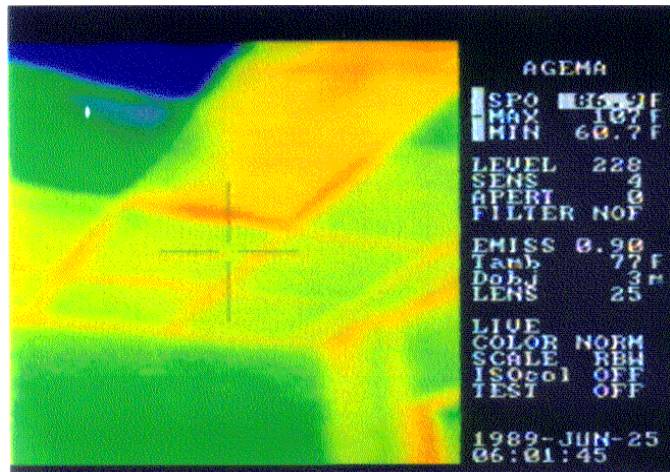
Figure 10. Infrared image of ceiling tiles between conditioned space and plenum looking from the conditioned interior. The ceiling surface temperature is 87°F.

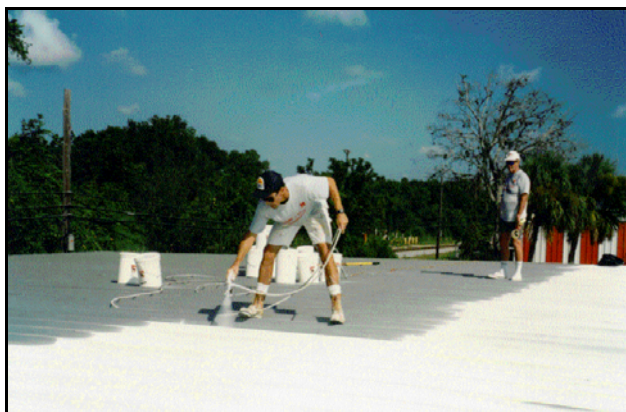
Figure 11

The galvanized roof of the two northern most store front were slated to be whitened on August 4th, 1996. However, problems with the weather delayed the initial application until August 11<sup>th</sup>. The un-surfaced metal roof was first cleaned using an acid wash on August 10<sup>th</sup>. The first coat was complete by 1 PM on the following day. However, weather appropriate to a second application was even more difficult due to rainy conditions in the month of August, and was only accomplished on 25<sup>th</sup> of the month. The first coat was applied on August 11<sup>th</sup> with second coat on August 25<sup>th</sup>, 1996. Figures 11 and 12 show the material in application.

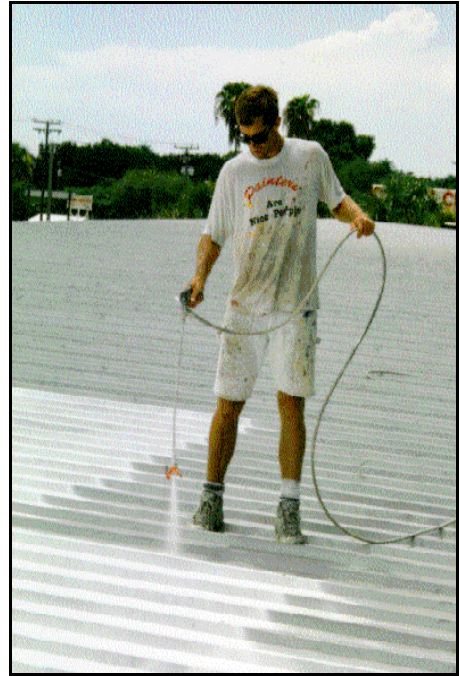
**Figure 13. Phase II roof whitening on July 30, 1997.**

The un-coated metal roof had a measured reflectance of 29.6%. The newly surfaced section of the roof had a solar reflectance of 77.4 ( $\pm 6.0$ )%. Figure 13 show the coating to the mall being applied to the remaining segment of the roof. Figure 14 shows the one year old white painted section of the roof against that being freshly coated. Finally, Figure 15 photograph shows a close-up of the one year old section of the coated roof. Little degradation of the white surface is seen. Although the difference in the means was 2.7% lower after a year of exposure, the value is within the statistical uncertainty of the measurements. While close physical examination of the aged surface reveals a very slight accumulation of small dirt particulate, the roof appears essentially as it did a year ago. This may indicate that the rate of degradation of white metal roofs might be significantly lower than for other less smooth types.

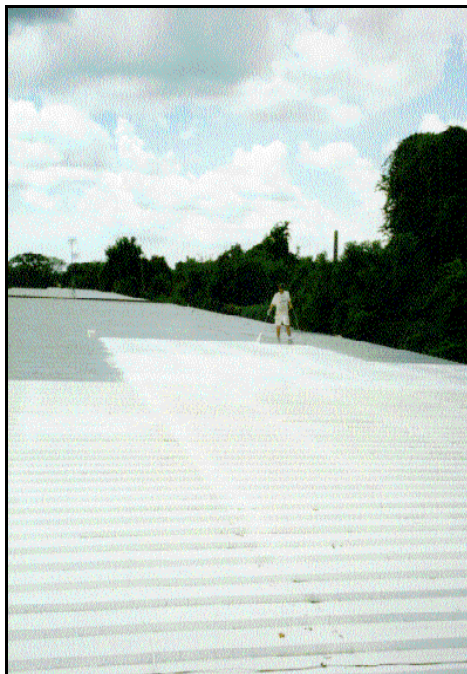
**Figure 14. One year old white roof surface (foreground) against freshly coated roof section.**

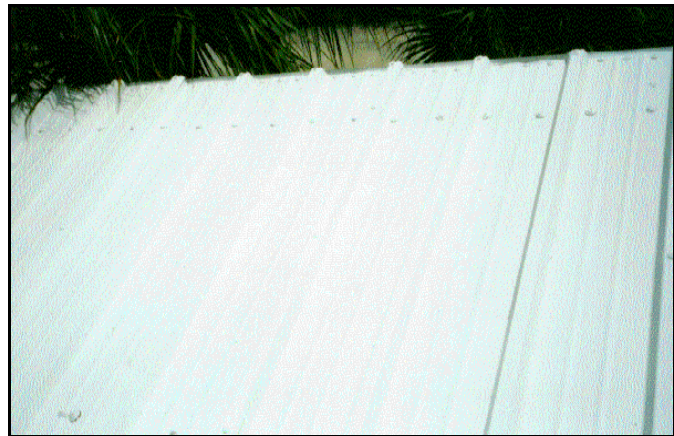
**Figure 15. Close-up of one year old white roof section.**

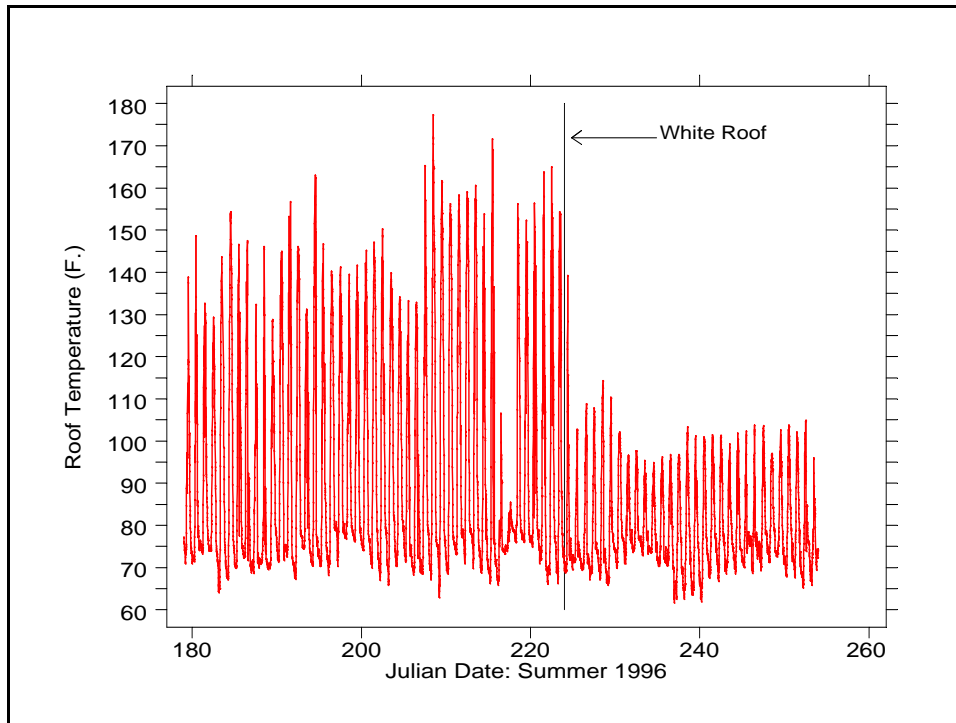
**Figure 20. Measured roof surface temperature above the bagel shop before and after roof re-surfacing.**

chosen for their similar temperature and insolation weather patterns. The pre-application day is August 9th (Julian day 96-222); the post application day is August 31st (96-244). Roof temperatures of over 170°F were recorded on the unmodified center and south sections of the roof, while the white north roof section maintains peak surface temperatures 70°F less. Peak plenum temperatures are also visibly lower. Recorded daily air conditioning power was reduced by 26% in the bagel shop and 27% in the realty office in spite of the post period day being 1°F warmer than its pre-application match. Interior comfort conditions also show evidence of improvement.

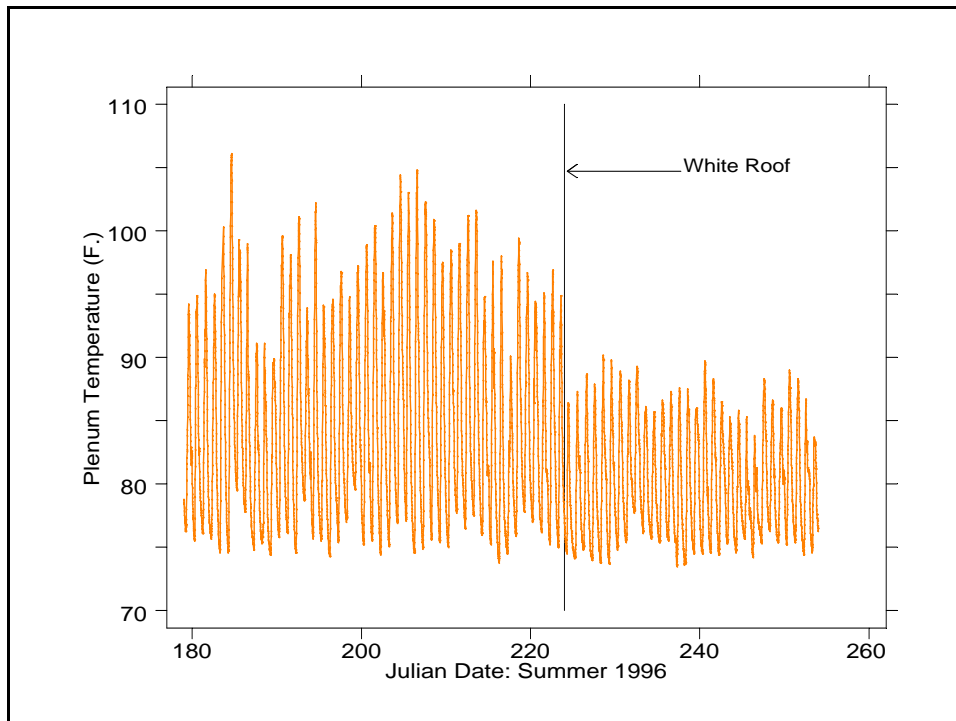
**Figure 21. Measured plenum air temperature above the bagel shop before and after roof re-surfacing.**

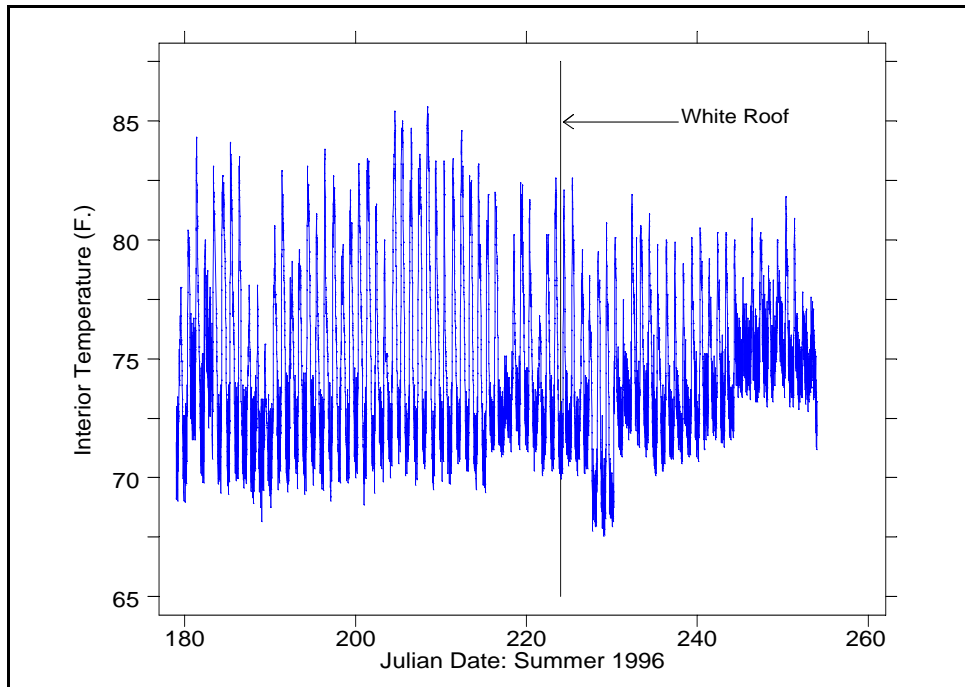
**Figure 22.** Measured interior air temperature above the bagel shop before and after roof re-surfacing. Note (1) how shop owners had to set the interior temperature higher post treatment to prevent too low temperatures in the morning and (2) the lower variation in interior temperature afterwards.

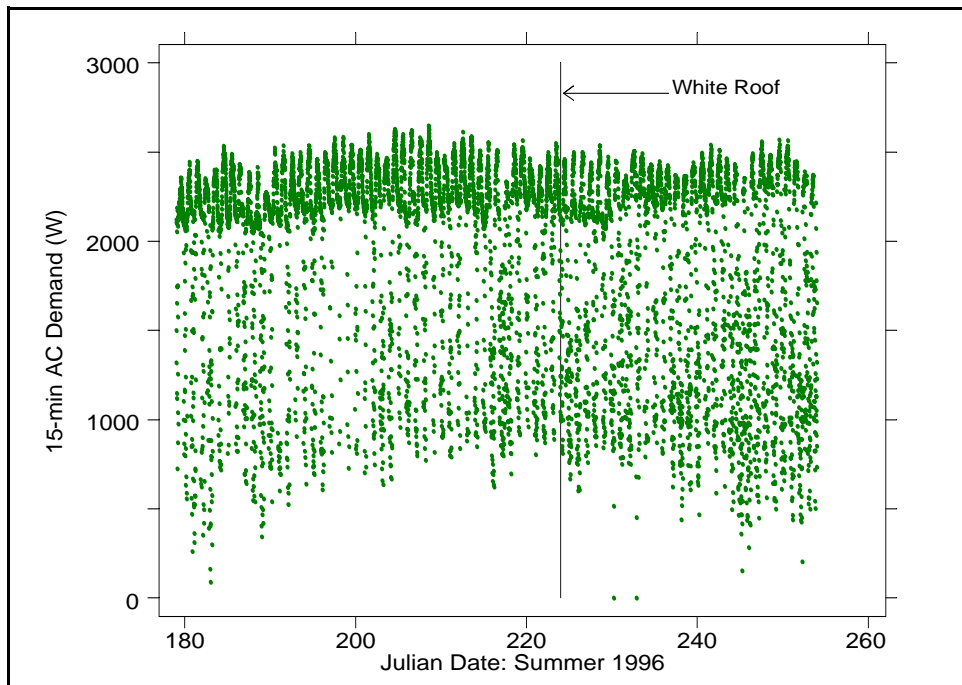
**Figure 23.** Measured 15-minute AC demand before and after roof re-surfacing at the bagel shop. Note fewer periods of maximum AC demand in the post period.

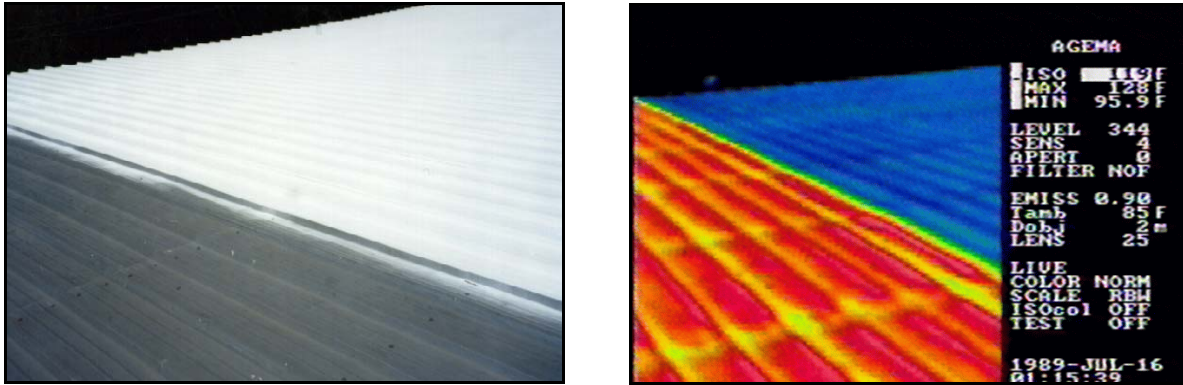
Figure 24. Comparison of visible and infrared image of coated and un-coated sections of the mall roof on July 16<sup>th</sup>, 1997.

We also used an infrared scanner to graphically illustrate how the roof surface thermal conditions were altered. Figure 24, with both a visible and infrared image of the paint line between the second and third shops, clearly shows the overall impact. In the infrared image, color is proportional to temperature. The image, which was taken at mid morning shows that the un-surfaced section of the roof has risen to over 125 °F, while the white section is thirty degrees cooler.

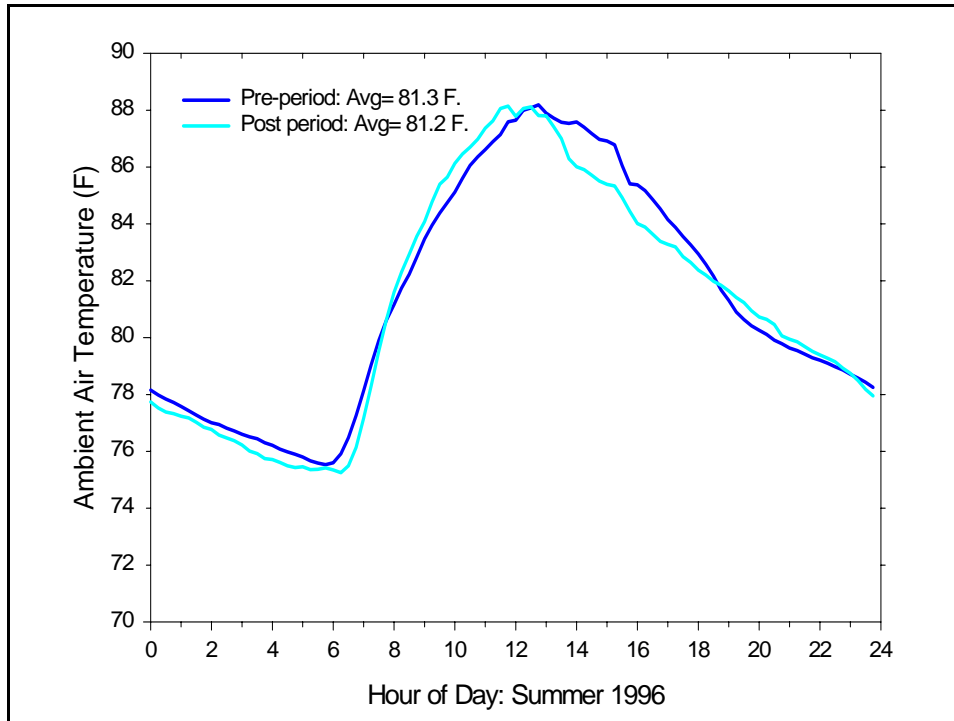
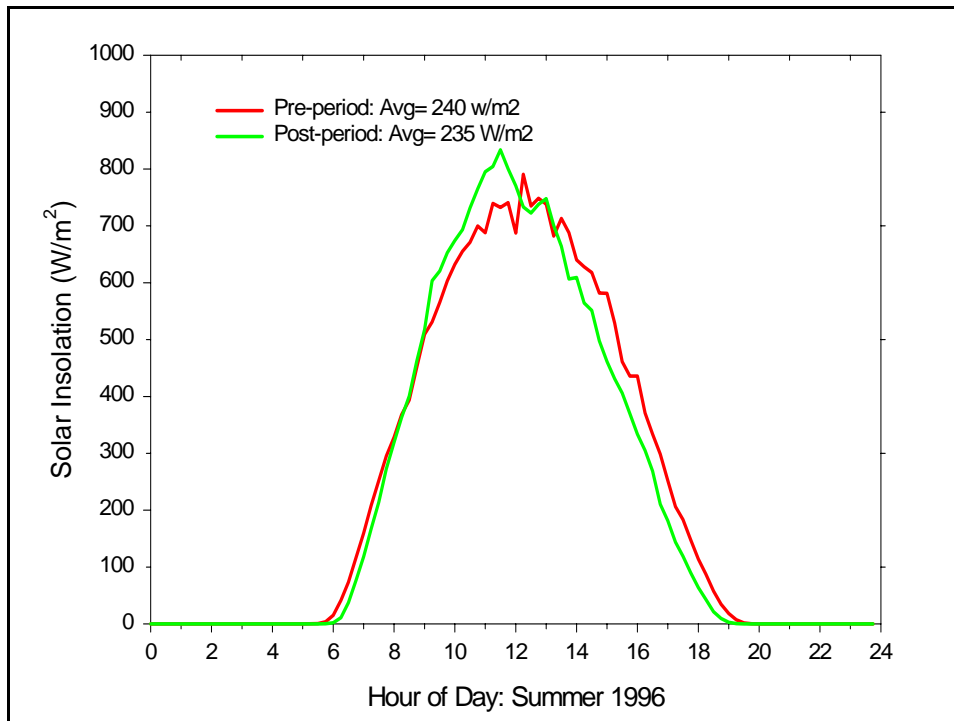
Figure 25. Match of weather data in the pre and post treatment periods in 1996.

Figure 25 shows the match of weather conditions in the pre and post period in 1996. Figure 26 shows how the roof surface and plenum thermal conditions were reduced. Finally, Figures 27 and 28 show how air conditioning electric demand and interior comfort conditions were altered from the roof resurfacing in the bagel shop and realty office, respectively. AC use was dropped by 13% and 19% in the two shops with peak hour reductions of 18% and 24%. Interior comfort conditions were also improved substantially in the bagel shop which is dominated by large internal loads from refrigeration units.

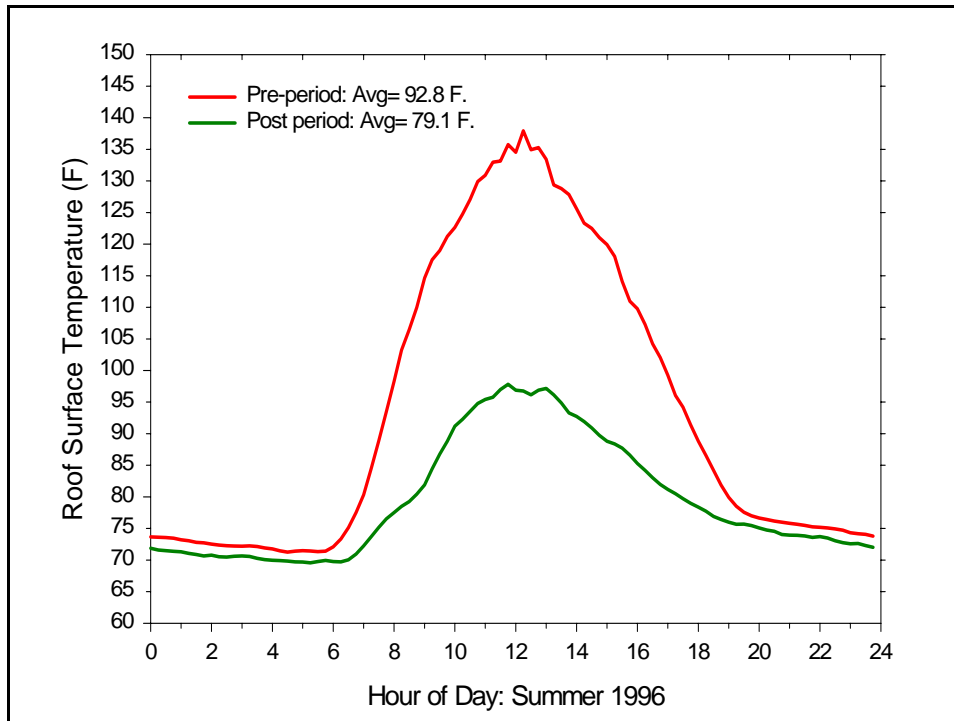
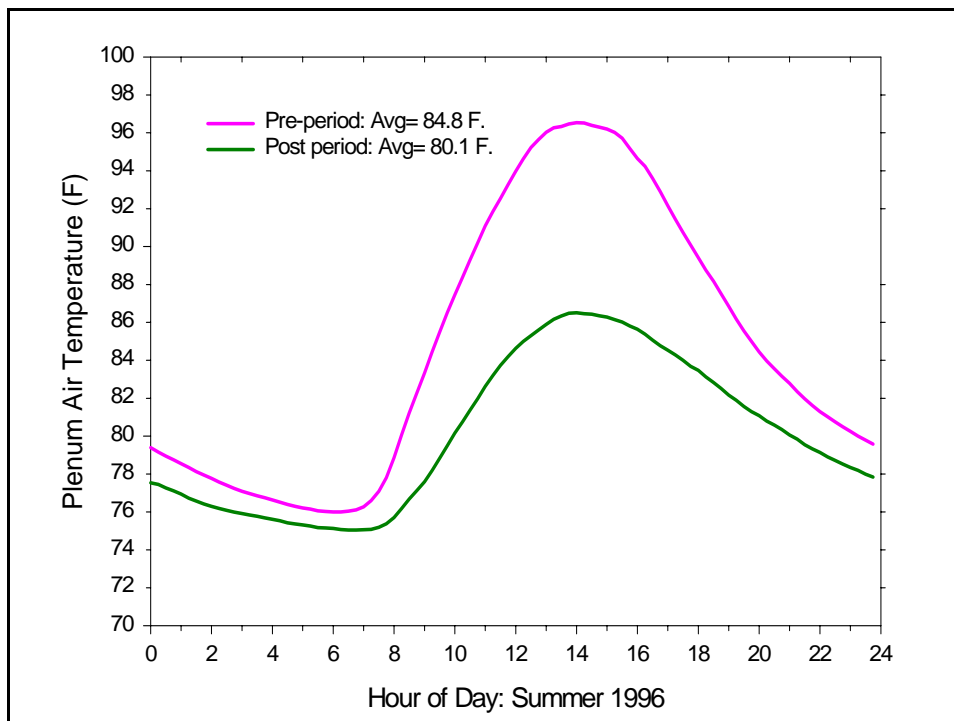
Figure 26. Measured average roof surface and plenum air temperatures above the bagel shop in the pre and post period in 1996.

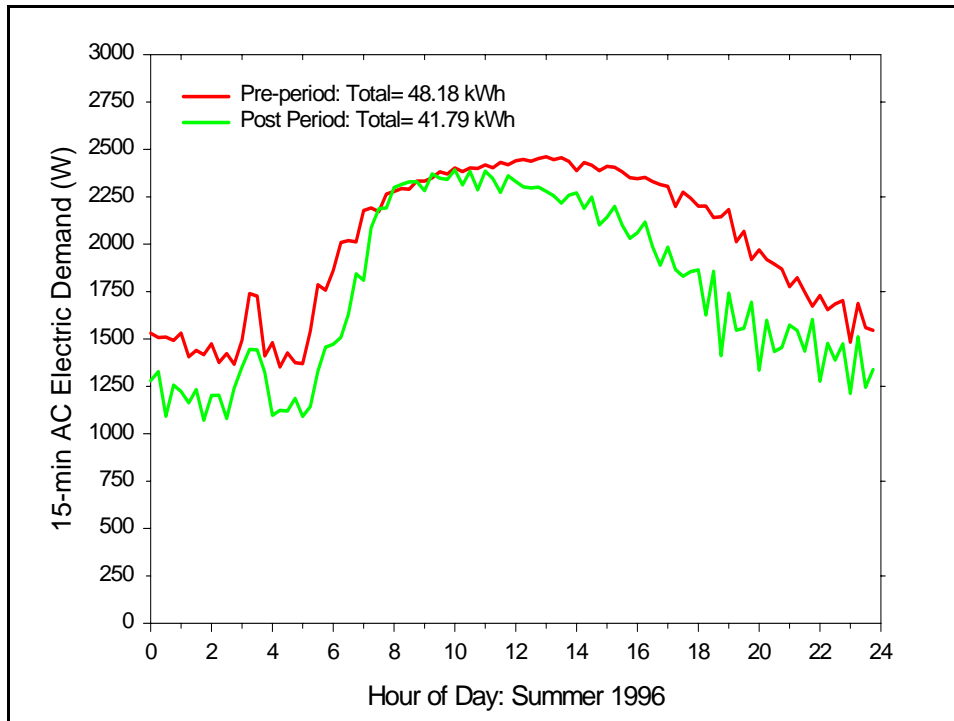
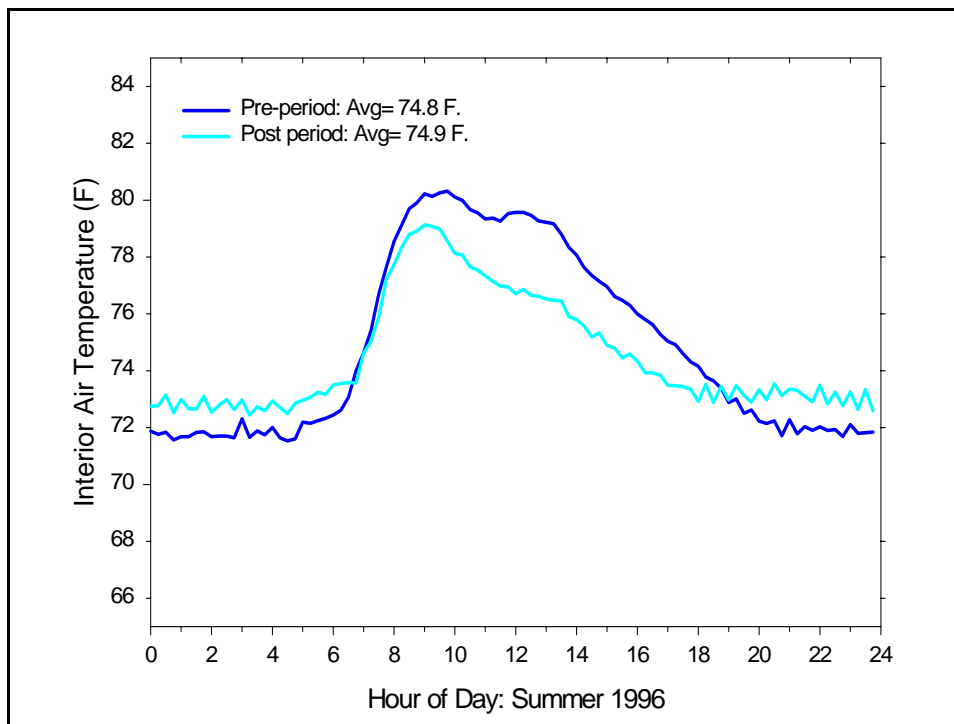
**Figure 27. AC demand and interior air temperatures profiles in the bagel shop in the pre and post periods in 1996. Note the influence of the east windows on the early morning temperatures and AC demand. Demand savings from roof treatment begins at roughly 11 AM EST reaching maximum at 6 PM.**

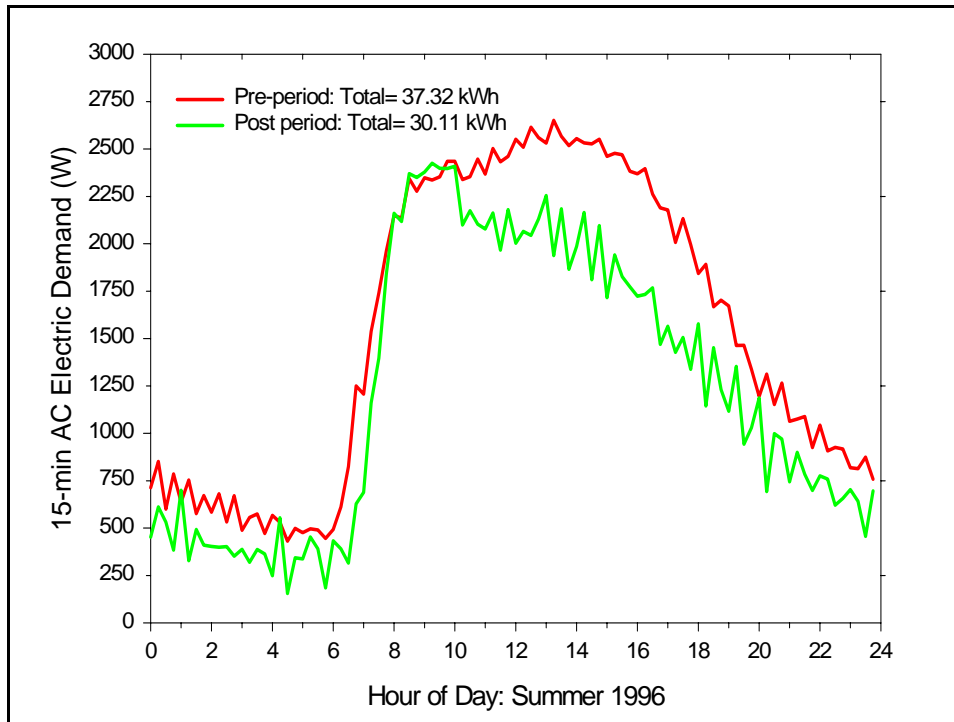
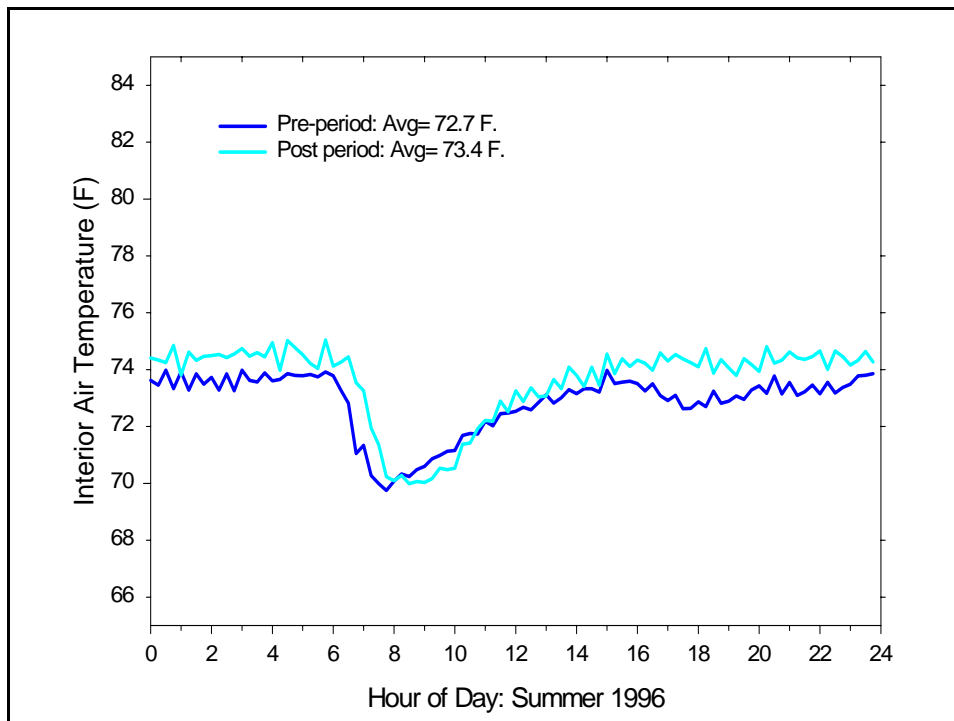
Figure 28. AC demand and interior air temperatures profiles in the realty office in the pre and post periods in 1996. Note the lower interior set temperature used in morning hours to compensate for heat gain through the east windows. Demand reductions from treatment begins at 11 AM and reaches a maximum at 4 PM.

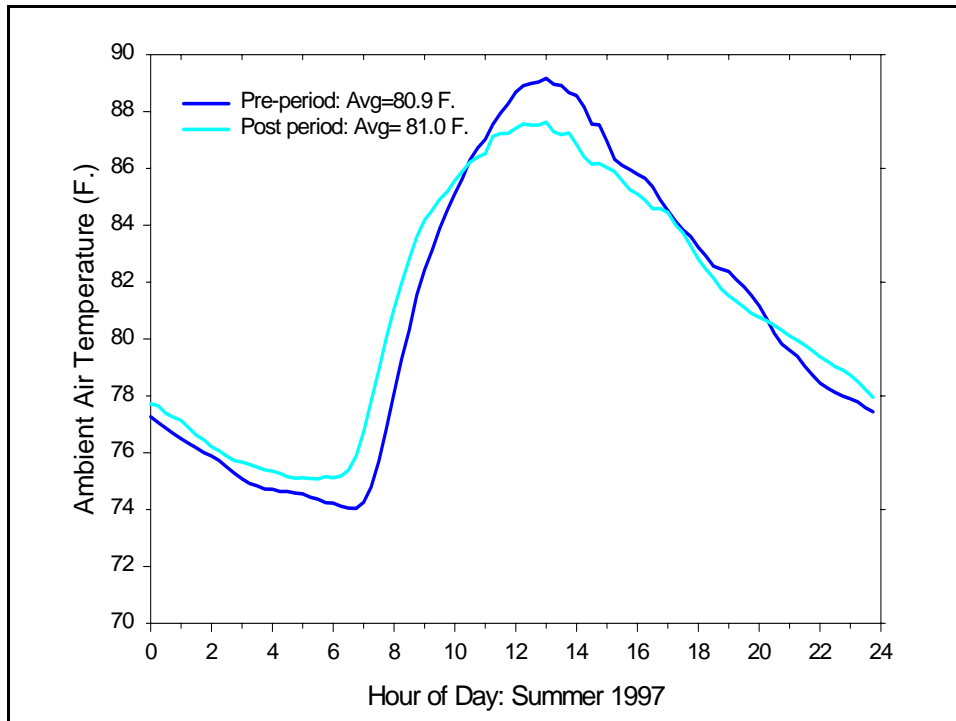
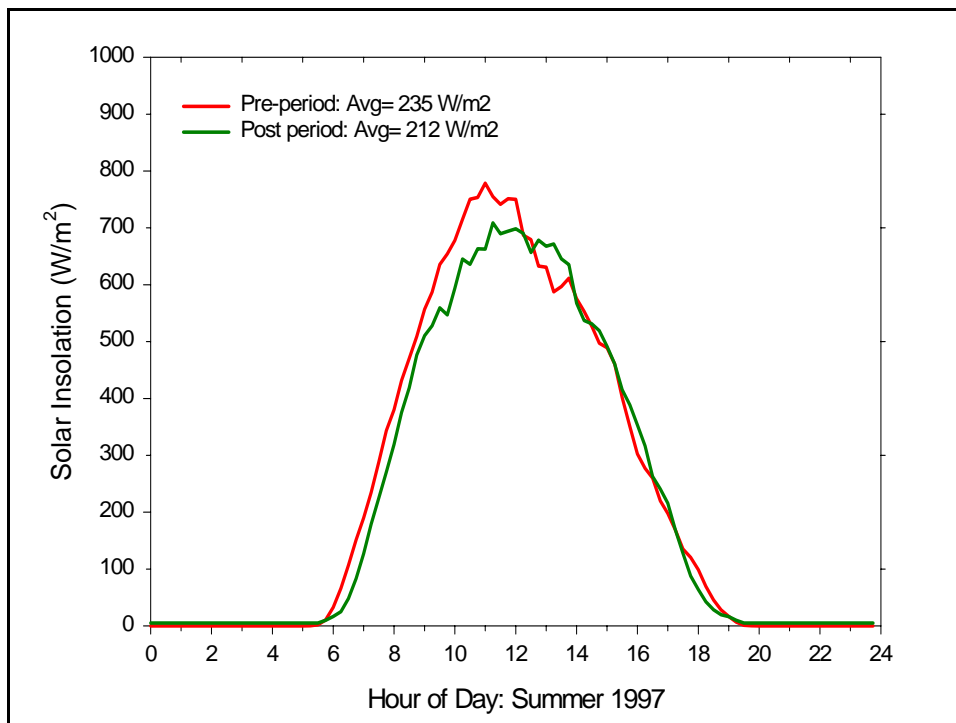
Figure 29. Match of weather data in the pre and post treatment periods in 1997.

The match of weather conditions in Phase II is shown in Figure 29. Figures 30 - 35 show how air conditioning electric demand and interior comfort conditions were altered from the roof resurfacing in each of the altered shops of the mall.

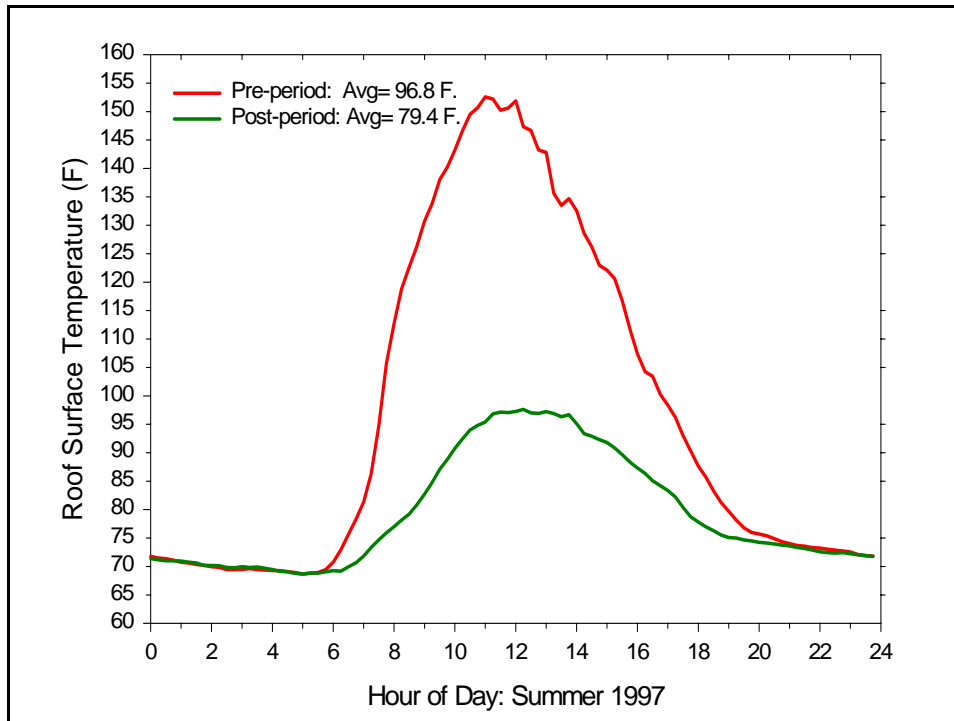
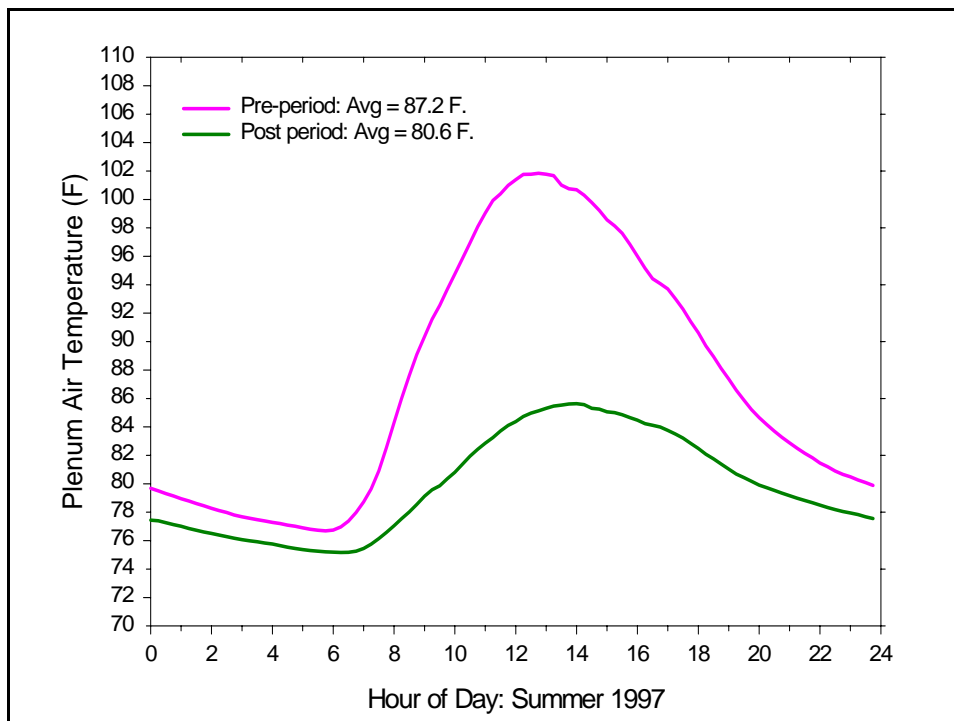
Figure 30. Measured average roof surface and plenum air temperatures above the book store in the pre and post period in 1997.

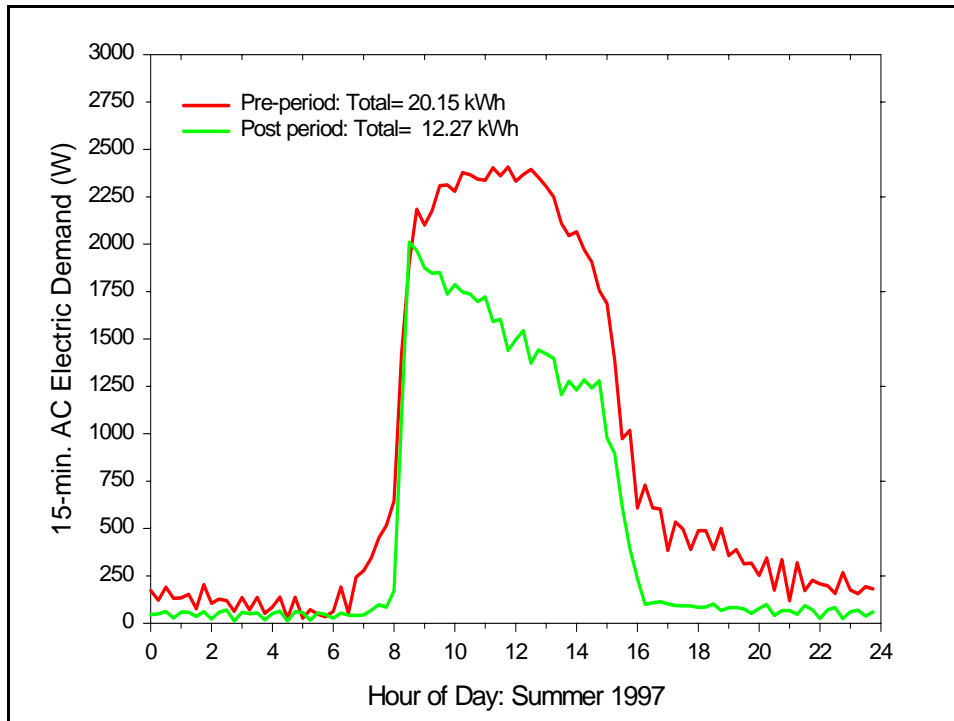
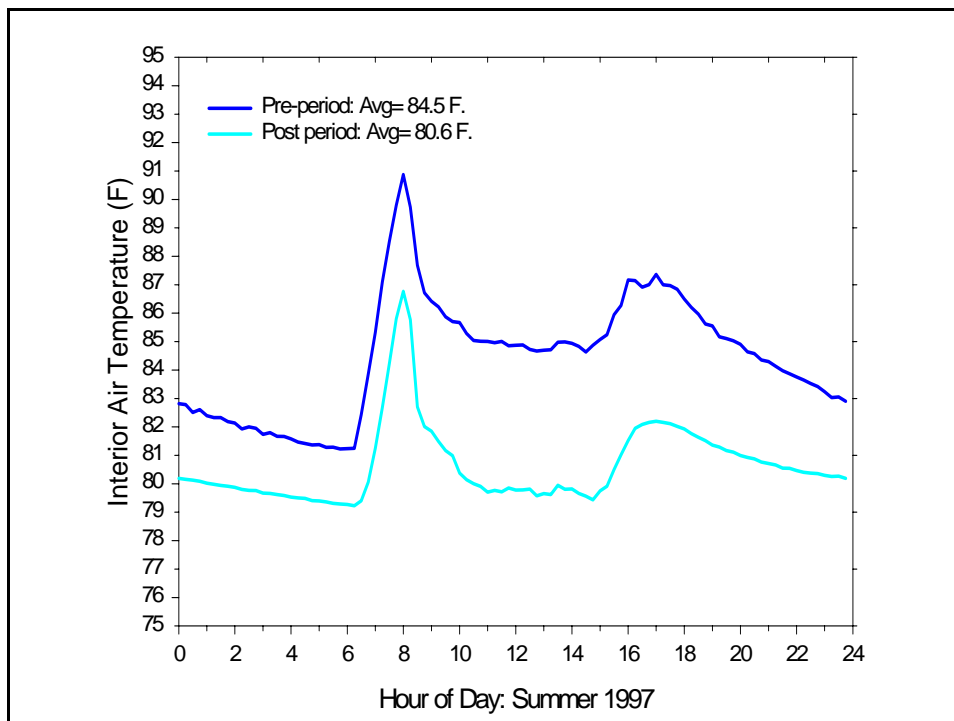
**Figure 31. AC demand and interior air temperature profiles in the insurance office in the pre and post treatment periods of 1997. Note the elevation in interior temperatures in the early morning from the east windows. Maximum demand reduction at 1 PM.**

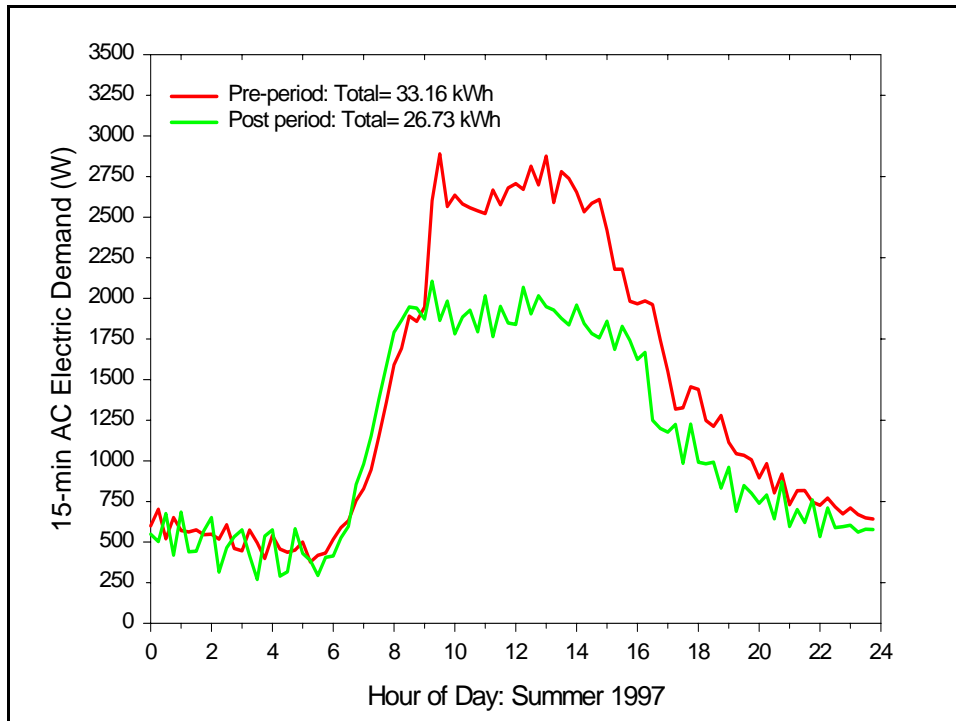
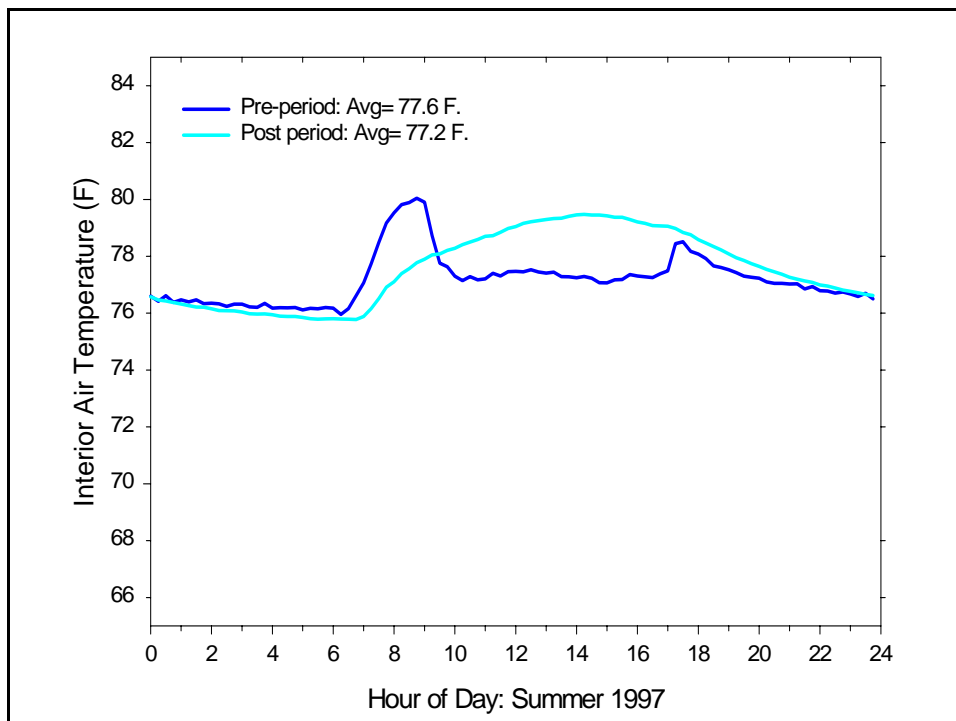
**Figure 32.** AC demand and interior air temperature profiles in the cell phone store in the pre and post treatment periods of 1997. Maximum demand reduction at 2 PM. Lower temperatures maintained while open (9 AM - 5 PM) in post period.
