# Demonstration of Cooling Savings of Light Colored Roof Surfacing in Florida Commercial Buildings: Retail Strip Mall

Danny Parker, Jeffrey Sonne, and John Sherwin

FSEC-CR-964-97

**FINAL REPORT**

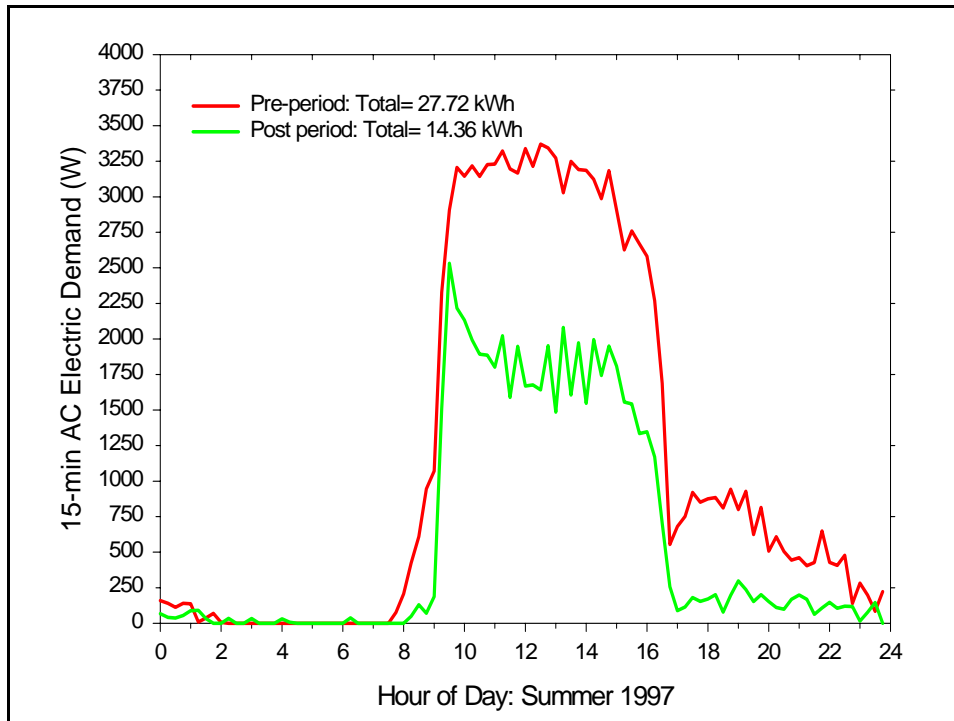
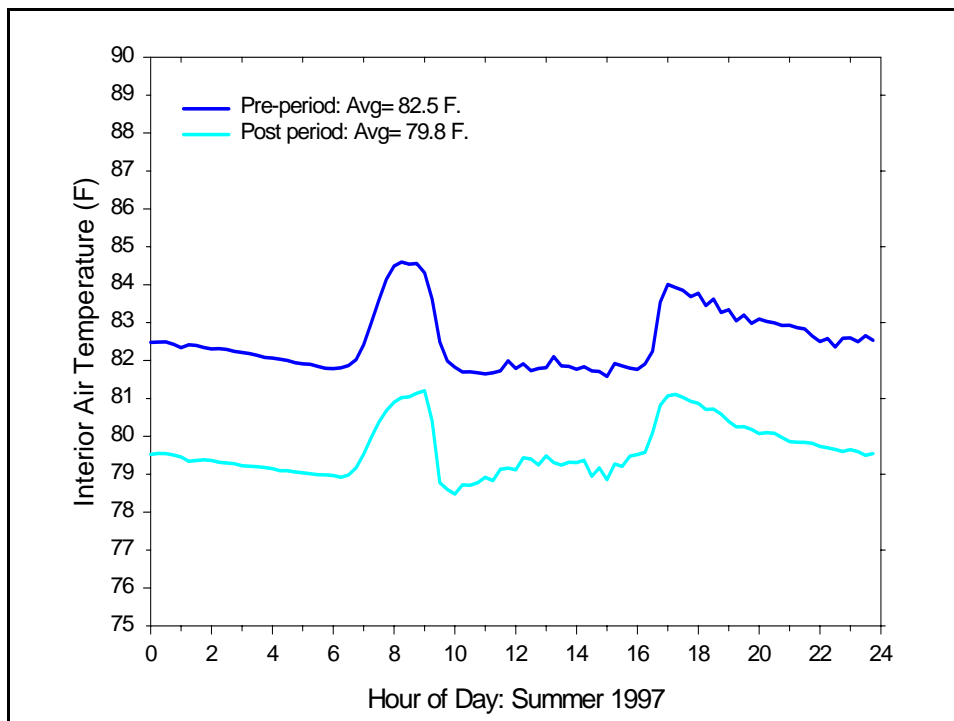
**Figure 33. AC demand and interior air temperature profiles in the book store in the pre and post treatment periods of 1997. Maximum demand reduction at 12:30 PM. Note much lower temperatures achieved after treatment.**

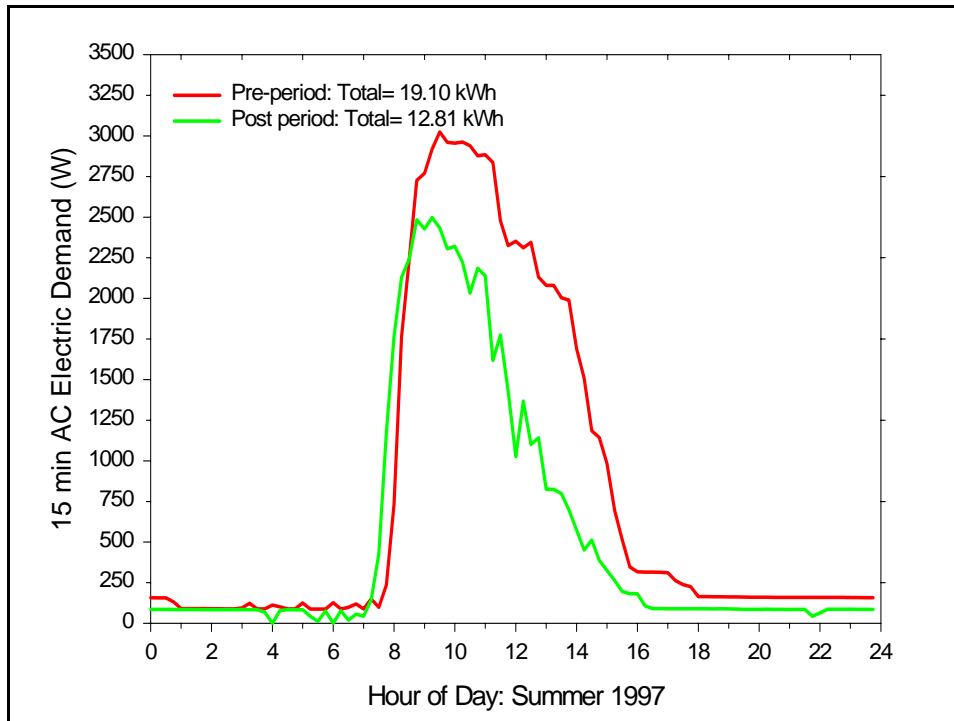
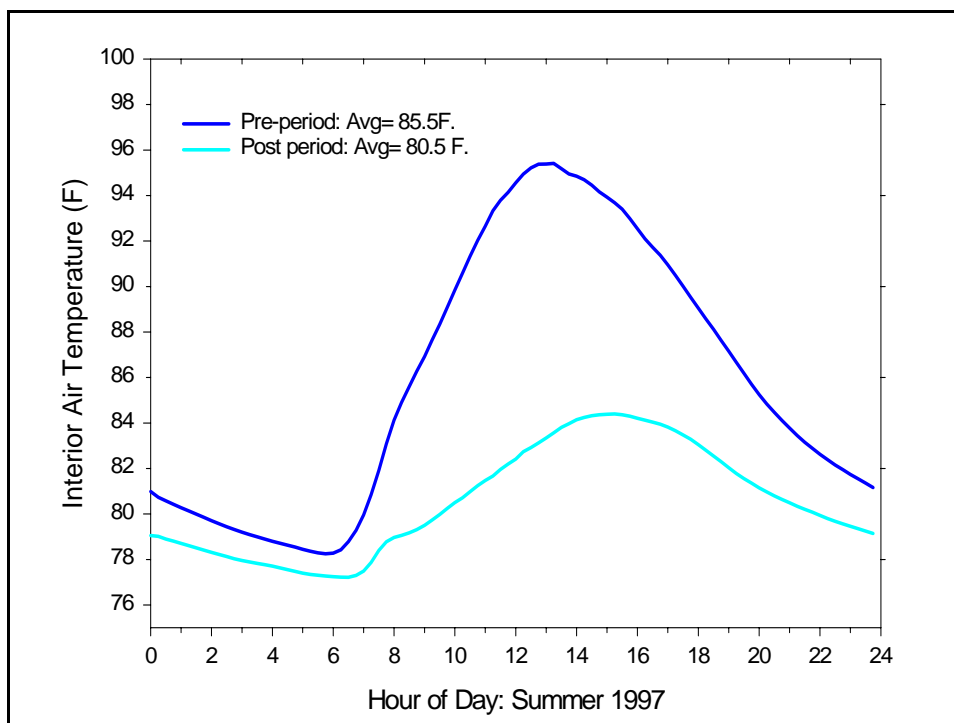
**Figure 34.** AC demand and interior air temperature profiles in the bedding shop in the pre and post treatment periods of 1997. The store was vacant during the 1997 monitoring period and the landlord had the thermostat set to maintain 95°F or less.

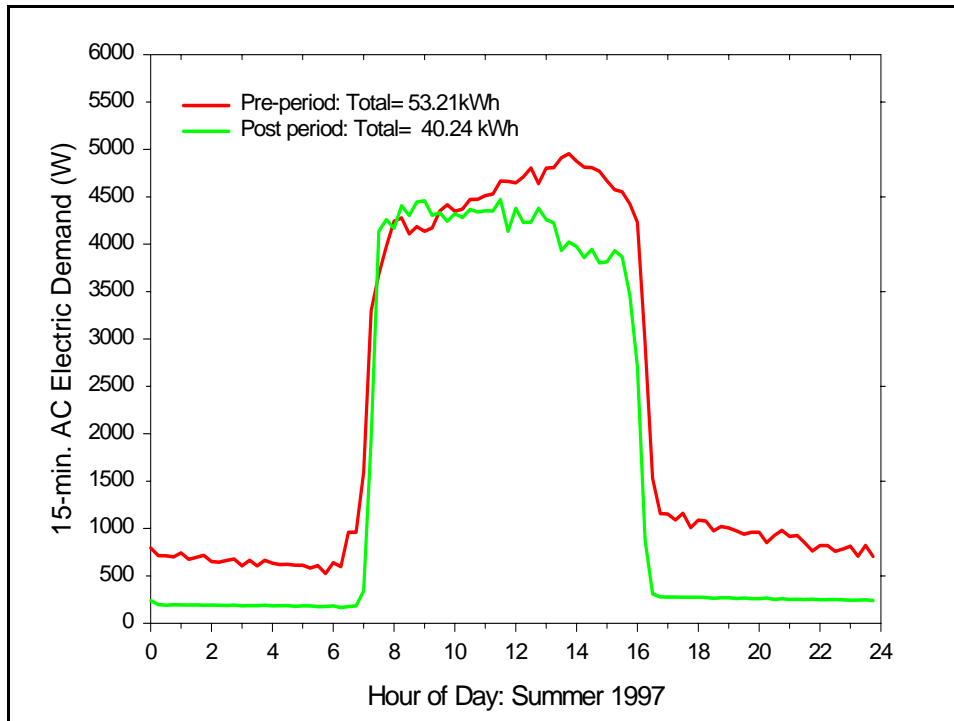
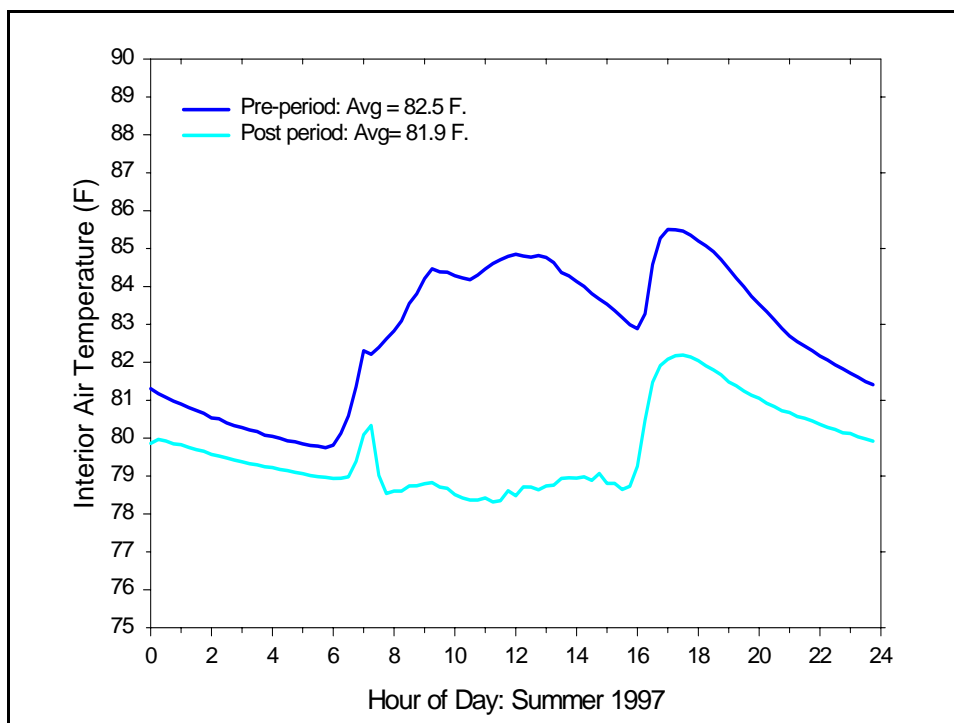
**Figure 35. AC demand and interior air temperature profiles in the daycare center in the pre and post treatment periods of 1997. Large savings in spite of substantially improved interior comfort.**

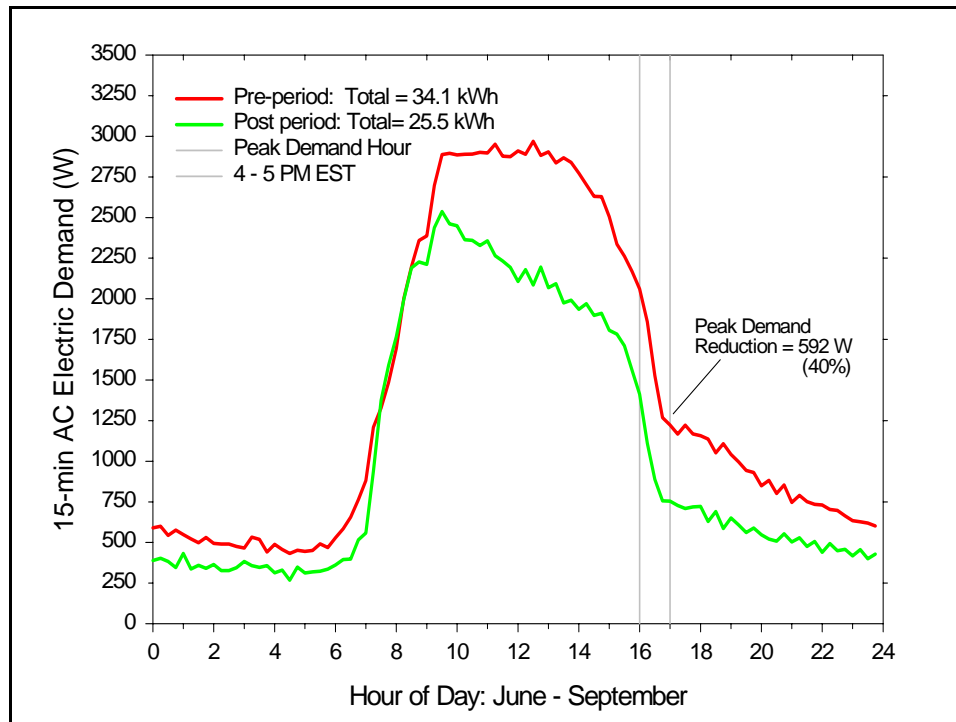
**Figure 36.** Average AC demand profile during pre and post treatment periods for all seven shops.
